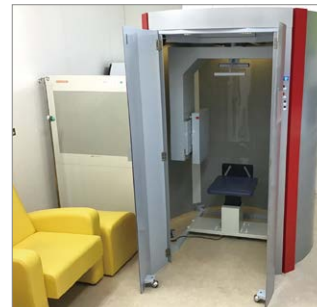
We carry out a chest X-ray and CT test in the examination room if the patient is positive (or if highly suspected) for COVID-19.

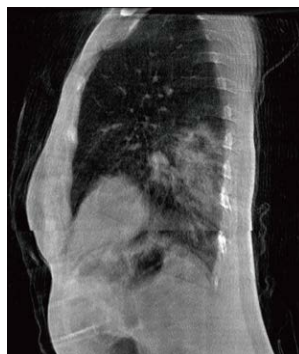
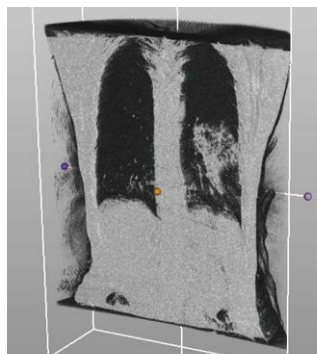
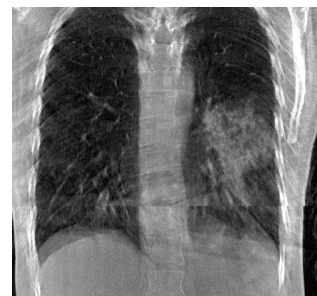
We are able to diagnose the presence of pneumonia by viewing images (including 3D images) on the server and the examination room PC.

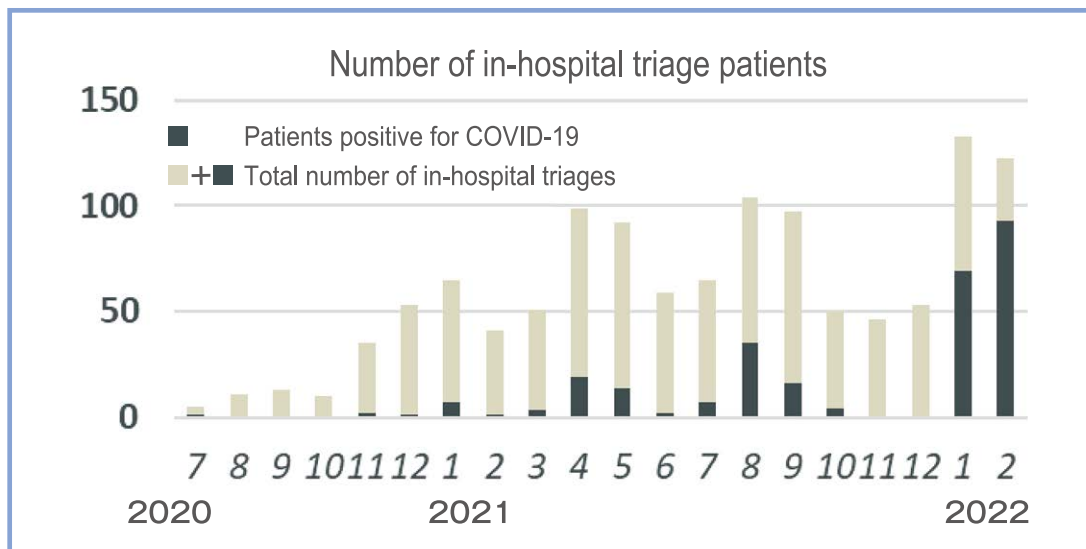
Of the 274 patients who tested positive for the COVID-19, 238 got a chest CT scan and 53 had infiltrative images and were diagnosed with pneumonia.

The device is a single-row cone-beam type CT, which is cheaper than multi-slice CTs. Educating staff for operation and preparation is easy. An X-ray room is not required due to the shield structure, and the sitting position photography method enables space-saving. Since it can be used with a household power supply of AC100V, it can also be installed in the clinic's examination room.
